IGNITION SYSTEMS

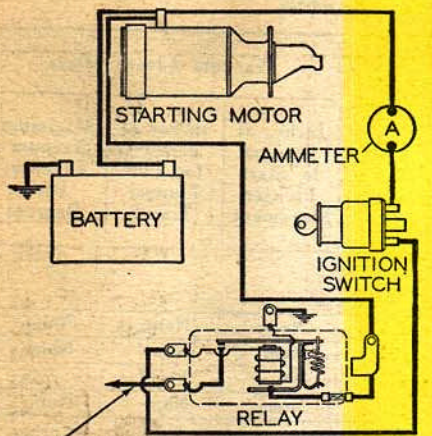
TO LOAD WHICH MAY CONSIST OF HORNS, FOG LIGHTS, RADIO, HEATER, OR ANY ADDED ELECTRICAL ACCESSORY

INSTALLED AS ACCESSORY LOAD RELAY TO RELIEVE LOAD ON IGNITION SWITCH

Fig. 25 Showing relay connected in ignition circuit to prevent overloading of ignition switch when accessories are connected through the switch

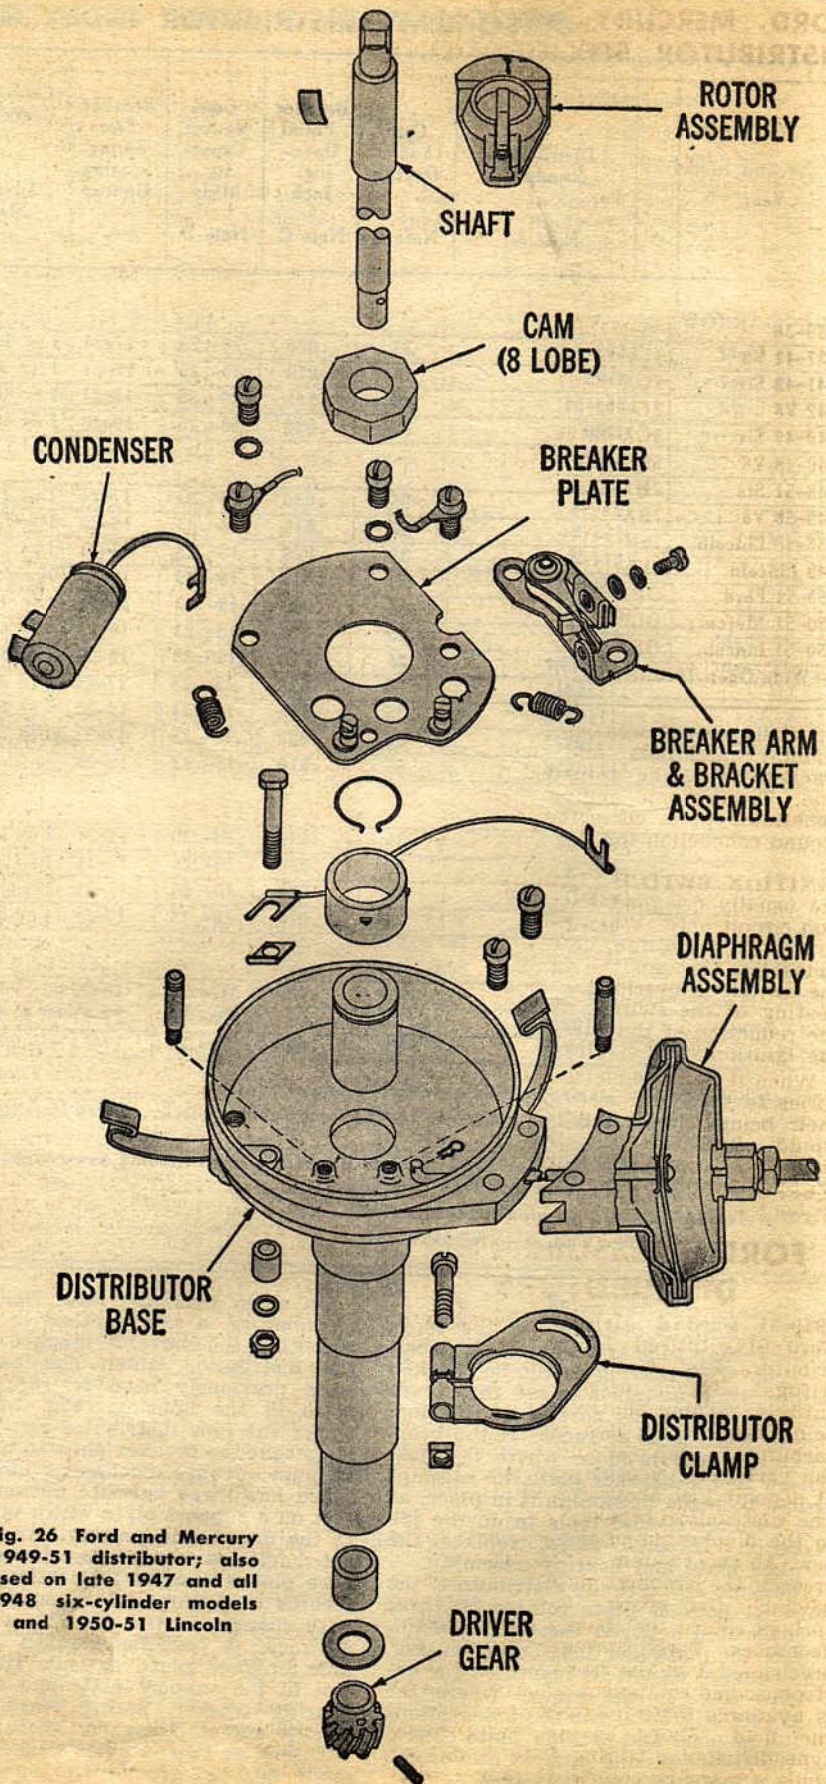
Fig. 26 Ford and Mercury 1949-51 distributor; also used on late 1947 and all 1948 six-cylinder models and 1950-51 Lincoln
